Mara River Flows

Integrated Water Resource Management

November 2009

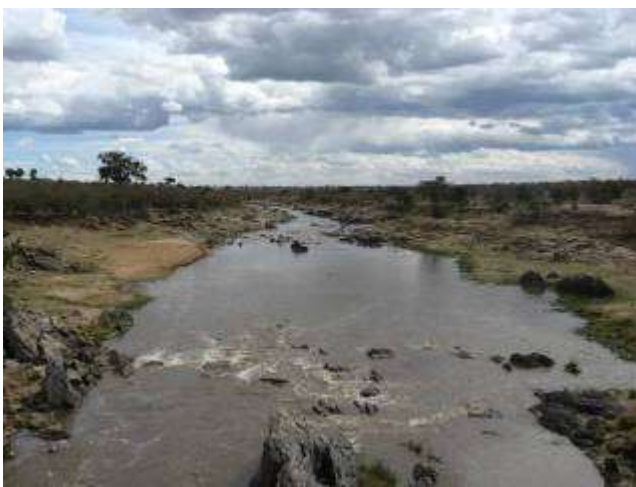
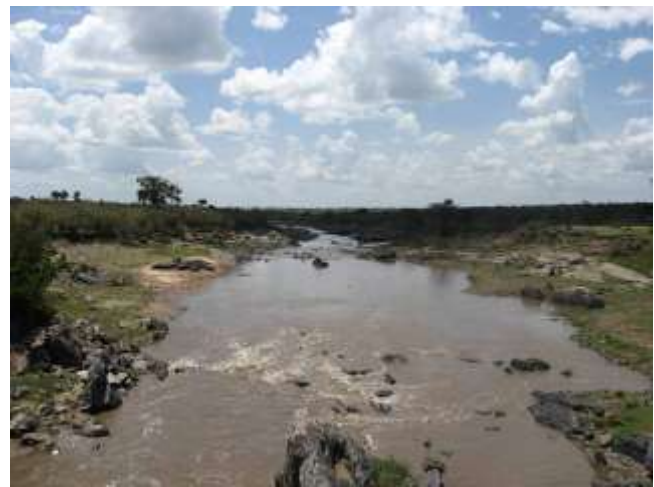
New Mara Bridge – October 15th, 2009

New Mara Bridge – November 14th, 2009

November started with remarkably low flow levels in the Mara River, and a Talek River that had essentially stopped flowing inside the Reserve. We were in Nairobi in the second week of November when we received a phone call from the Chief Warden of the Narok County Council side of the Masai Mara. His rangers had just reported a lot of dead fish along the bank of the river, the morning after the first heavy rain of the season. We rushed back to the Mara as soon as possible, but we had missed what turned out to be a pulse event. The fish kill only occurred just after the first rain, with no new carcasses appearing in the subsequent 3 days of heavy rain that followed. By the middle of the month, the river had dropped back down to levels even slightly lower than we saw in October, which you can see reflected in both the photos and water quality data shown below.

Water quality parameters for the Mara River

<i>Date</i> M/D/Y	<i>Time</i> hh:mm:ss	<i>Temp</i> C	<i>pH</i>	<i>DO%</i> %	<i>Salinity</i> ppt
10/15/2009	14:21:08	25.33	7.11	73.7	0.07
11/14/2009	14:22:40	26.25	6.88	66.5	0.08

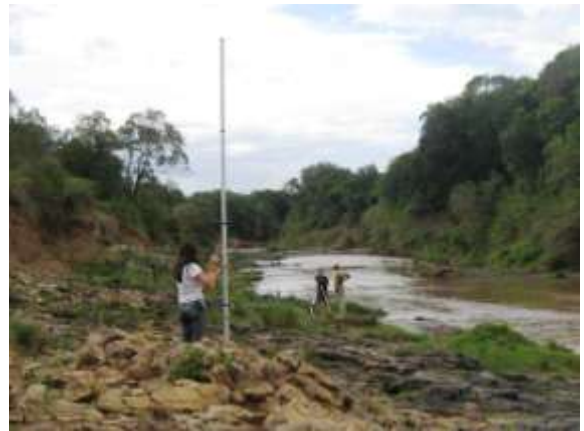
Picture 1: Veronica, Fred and Amanda measuring a benchmark transect on the Mara River.

Recently, some people have asked us why we don't include discharge data for the river in our newsletter. Indeed, discharge, or flow level, is considered a "master variable" in river ecology, and its relationship to water quality and ecosystem health in the Mara is the foundation of our research and monitoring. However, discharge data is normally taken using a staff gauge to measure river height, and there are currently no staff gauges on the Kenyan portion of the Mara River. The [Kenya Water Resources Management Authority \(WRMA\)](#) is working hard to resolve this issue, but they are challenged by a river that tends to sweep away staff gauges. In the meantime, we use a surveying rod and level to measure water surface level in relation to transects established during the Environmental Flows Assessment, and we work with a hydraulic engineer to estimate discharge using a rating curve he built for the transects. It's a bit complicated, and it takes some time to get the discharge data, but it yields critical information needed to interpret the rest of our findings.

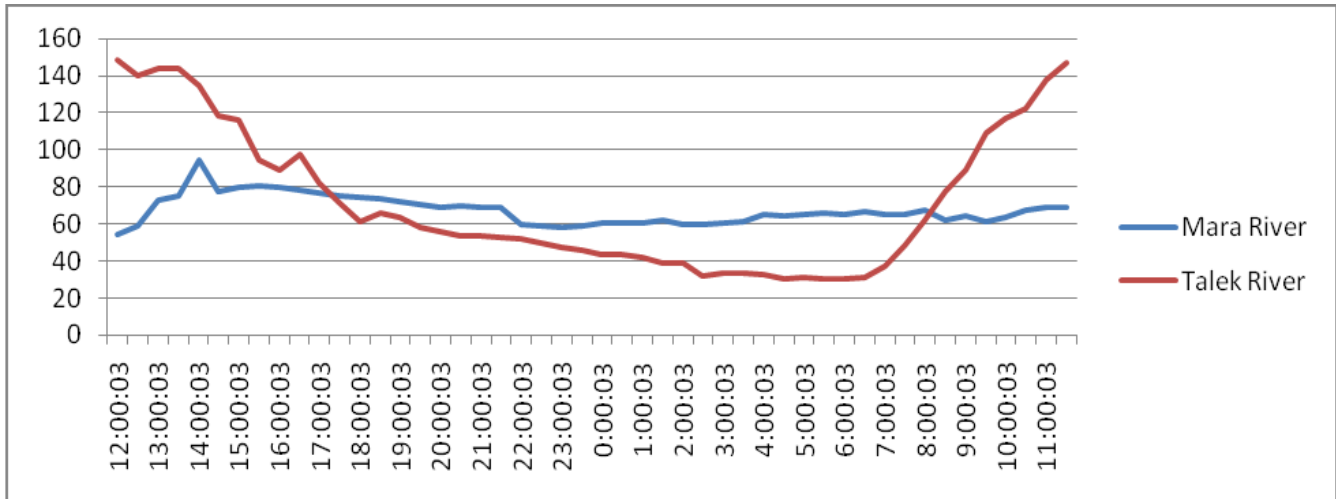
Figure 1: Percent saturation of dissolved oxygen throughout a 24-hour period in the Talek River on October 31st and the Mara River on November 1st, 2009.

The difference between the two rivers is remarkable. Both rivers showed the same pattern of rising DO levels during the daytime and decreasing levels at night. However, the Talek was far more extreme, fluctuating between 30-144%, while the Mara ranged from 56-95%, as you can see in the graph below. This variation between the two is probably indicative of the highly eutrophic nature of the Talek, particularly under very low flow levels.

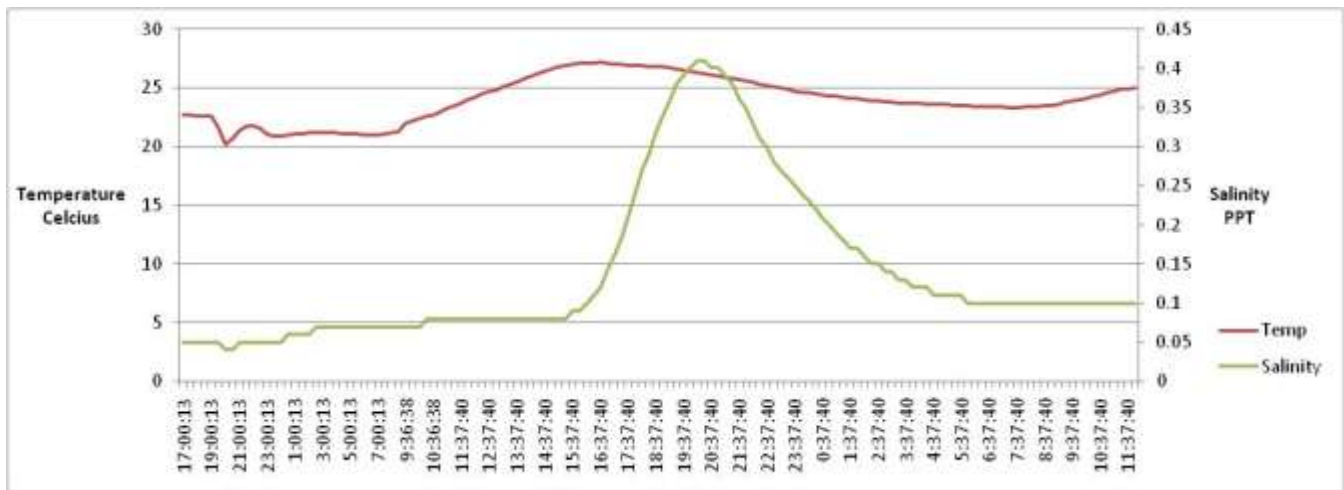
Figure 2: Salinity and temperature readings throughout a 42-hour period in the Mara River from November 13th through November 15th, 2009, three days after a large fish kill. Rain events occurred at approximately 17:30 on both days.

After the fish kill happened two weeks later, we wondered if the first rains had caused a flush of nutrients into the system, which could have resulted in a wave of very low DO water that could have essentially suffocated the fish. We left our meter in the river for 2 days, hoping to catch another rain event and the subsequent impacts on water quality. Unfortunately, the very turbulent water destroyed the membrane on our DO meter, so we didn't get any DO data. However, we did observe some very interesting patterns. Both evenings, we experienced short but intense rainstorms at around 17:30. The first night, there was a small drop in both temperature and salinity, and we measured the turbidity at 1,300 NTUs just after the storm. The second night, there was a huge peak in salinity, over 5 times the level from earlier in the day. We're not sure what caused this peak, or why it happened the second night but not the first. It may have been related to where in the catchment the rains were falling, and what was being washed into the river. Either way, it taught us a lot about how dynamic the Mara River can be, and how important it is to monitor frequently. What exactly caused the fish kill is still a mystery to us, but we collected some water samples and aquatic insects, and we hope the analysis of these will yield some more information. To read a great summary about the event, check out this link to one of Chris's blog postings: <http://maraadventure.blogspot.com/2009/11/another-large-fish-kill-in-mara-river.html>

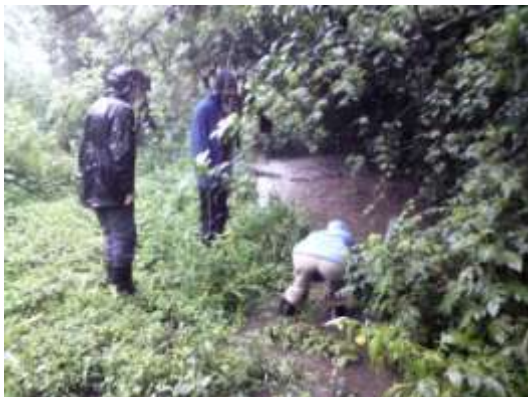
Picture 2: Sampling during a hailstorm in the Mau Forest

Mara. Specifically, they are comparing streams that originate entirely from forested areas with those that originate entirely from cultivated areas, and they are already seeing striking differences. For example, many of the streams in cultivated areas are no longer flowing after the extended drought, while those from the forest are still flowing. Their data will be critical to understanding the impacts of deforestation in the Mau as well as current efforts to restore the forest. We had the pleasure of accompanying them during several days in the field, and although it was an incredible adventure, it was also remarkably challenging. The first day, we hiked 5 km into the Mau Forest and then took samples during a hailstorm!

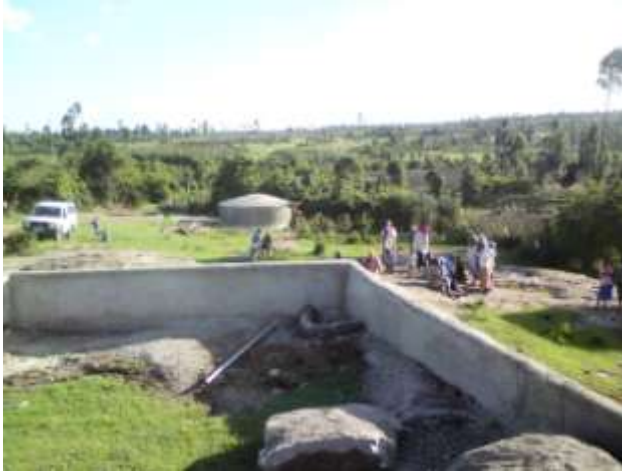
Picture 4: Rock catchment with water storage tank downhill

partners in this project—WWF-ESARPO. This month, we visited with [WorldVision – Kenya](#). WorldVision has been doing some excellent work in the Kirindon District of the Mara River Basin since 2004, with support from USAID since 2007. We were excited to visit one of their recently constructed projects that was new to us—a rock catchment. Elegant in design and built to compliment a unique natural feature, rock catchments are rainwater harvesting structures for those blessed with large rock outcroppings in their backyard. A fence around the rock protects the surface from contamination and the water running off the rock face is funneled into a storage tank.

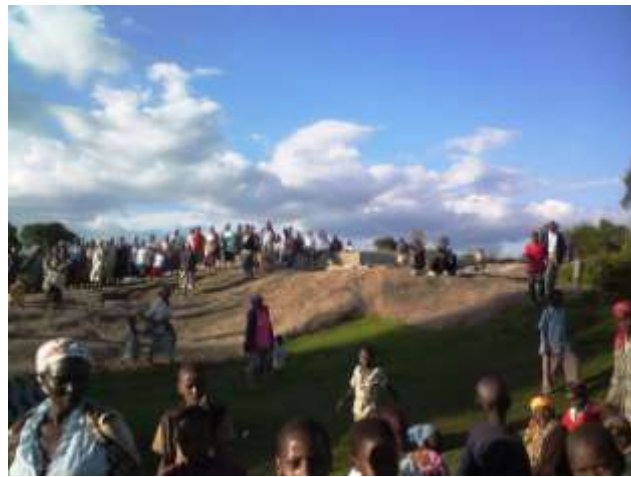
Picture 5: Community in Kirindon on their rock outcropping

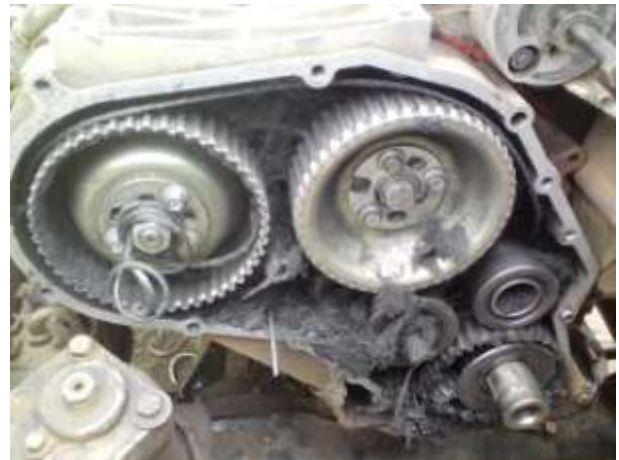
Picture 6: Shredded timing belt on our trusty Land Rover

We learned very quickly how important timing belts are when we realized other parts of our engine had broken or bent during the belt's demise, but we were incredibly lucky to be helped out by some great friends. The mechanics at the [Mara Conservancy](#) towed our truck out of the lion pride and spent two days helping us re-build our engine, and the good folks at [Governor's Camp](#) sent over some engine parts to get us rolling again. Just another grand adventure inside the Masai Mara!
